## Case Study: 015

An underground fire closed Daw Mill colliery in 2013. Since then work has been underway to put the fire out and make the site safe. A major part of this work has involved filling in the 2 mineshafts, which required a specially engineered cover plate to be constructed. This work has been undertaken by ECS Engineering Services in conjunction with JMC on behalf of the Coal Authority.

## Daw Mill Mineshaft Cover

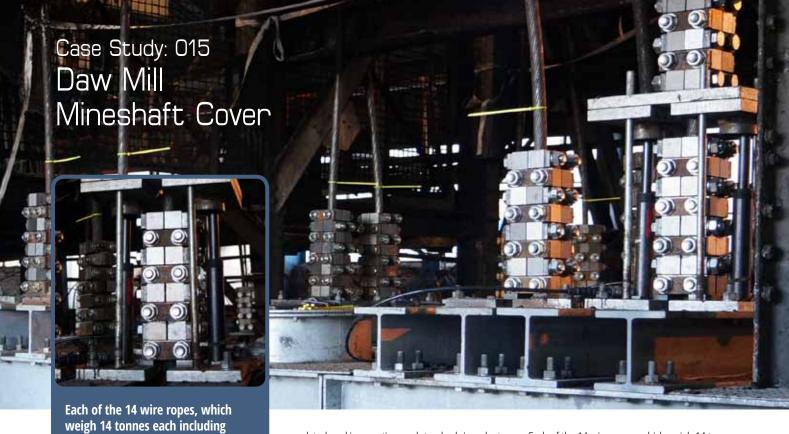
JMC Engineering (UK) appointed ECS Engineering Services to design and construct the structure which will allow shaft No.1 to be filled safely. The cover consists of fabricated structural steel box work to span the gap, supporting reinforced steel joists (I-section beams) that support the cable clamps. The cable clamps are constructed of a series of solid steel bolted clamps attached in series above the I-beams.

The structure was fabricated at ECS's own 40,000 sq ft fabrication works and had to span the 6.5m wide shaft opening and be capable of supporting the 200 tonne load with the necessary 5 to 1 safety factor, as required in the coal industry. It also had to have a design life of 25 years, just in case the project remained incomplete for any reason. The top section of the framework supports the 2-bolt rope clamps, which are bolted onto the wire ropes which themselves have a 2 to 1 safety factor.

Each of the 14 wire ropes, which weigh 14 tonnes each including weights, is fitted with eight 2-bolt clamps and then raised using a hydraulic jack sufficiently to allow a second set of clamps to be installed below the first. This procedure allows the tension in the wire rope above the framework to be released, making it safe to cut the rope and disconnect it from the head gear framework.

Once the rope clamps have been installed, a highly visible marker is attached to each rope and the distance to the clamp measured and recorded. As an additional check, these distances are measured every day to ascertain if there has been any slippage of the wire ropes.
