**The National Coal Mining Museum for England has been receiving visitors for over 25 years. As with most coal mines, there is a constant build up of water in the underground workings that makes its way to the old mineshafts. This water needs to be pumped out and treated before it is discharged into the local watercourse. ECS Engineering Services has been responsible for maintaining the pumps and the treatment works for the past 18 years.**

# Maintenance Services for NCMEM

# Case Study: 012

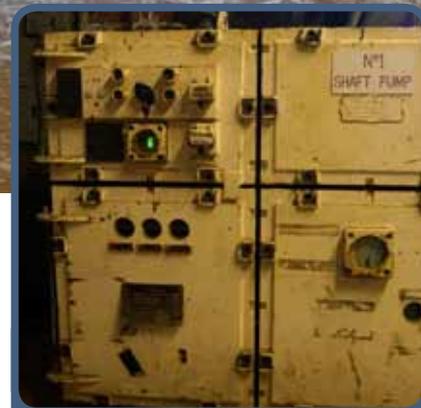
**The maintenance aspect of the contract aims to ensure continued efficient operation of the pumping and treatment equipment**

The maintenance aspect of the contract aims to ensure continued efficient operation of the pumping and treatment equipment. The main issue to be addressed is the continuous build-up of ochre deposits which restrict pipes, block the cascade and fill up the settlement lagoons. The pumps themselves are removed for maintenance on a rotational basis about every 18 months, but this is no small operation.

The Hope shaft in which the pumps are located is within the Museum area, with the head works still in place above the mineshaft. In order to remove a pump, the head works must be lifted off the building to allow the discharge pipework

and pump to be lifted out of the shaft. Once the replacement pump has been installed, the head works have to be replaced to maintain the appearance of what is a historic building.
